An investigation into the rehabilitation of timber structures with fibre composite materials

M.F. Humphreys

Queensland University of Technology, Brisbane, Australia

ABSTRACT: Timber was the material of choice for a large number of Australian infrastructure projects during the 19th and early 20th centuries. Many of these timber structures have lasted well and remain in use today. However, some important timber structures, particularly timber road and rail bridges, are reaching a critical point in their life as codes call on them to carry loads above their capacity or their condition has deteriorated to a point where they are no longer considered safe, or a combination of both. It is often not financially viable or convenient in the short term to replace these bridges. It is proposed it may be possible for managers of civil infrastructure to be able to quickly, inexpensively and significantly improve the structural behaviour of timber bridges and extend their service life until they are able to be taken out of service and replaced. This paper investigates the use of fibre composite materials to rehabilitate timber structures such as these. In this preliminary study unserviceable t

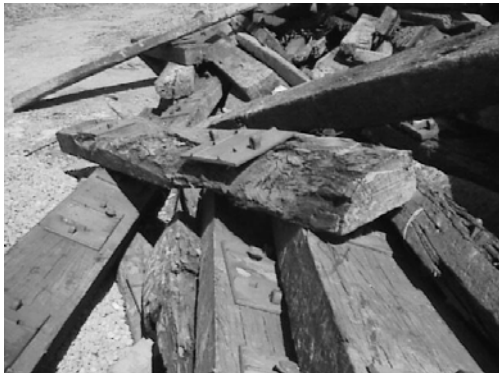
Timber railway sleepers are discarded in different states of well being. These range from severely deteriorated with significant signs of physical degradation, to those which have been incidentally removed due to the economics of replacing track sections, rather than individual ties. Figure 1 shows an example of the type of variation in physical condition that could be observed in groups of discarded timber sleepers. These could be seen as representative of the type of tie condition that a rehabilitation system would have to be able deal with.

Figure 1 – Unserviceable timber railway sleepers

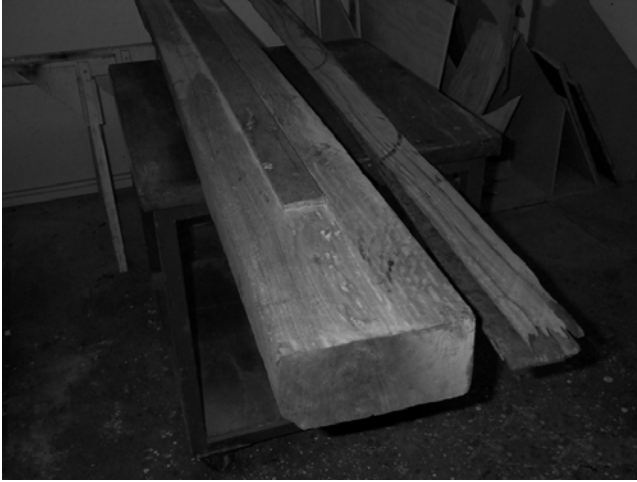
wood on the bottom surface of the sleeper by slicing and dressing two 75mm wide strips of outer material to a depth of 15mm on the bottom surface. Figure 4 shows a typical prepared specimen.

Figure 4. Typical prepared sleeper specimen

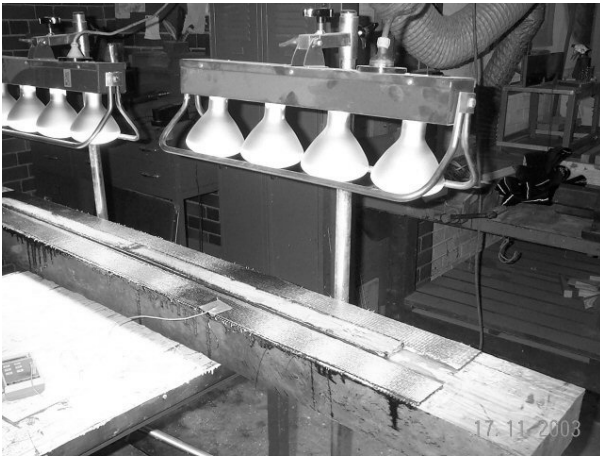
Carbon fibre / epoxy laminates were proposed for this series of tests due to the carbon's failure strain and elastic modulus and epoxy resin's bonding ability. 300gsm unidirectional fibres were sliced into 75mm wide strips and hand-laminated onto the dressed bottom surface of the sleeper. The laminated strips were post-cured at 80°C for 8hrs. Figure 5 shows the sleepers during post-curing.

Figure 5. Post-curing carbon / epoxy sleeper laminates

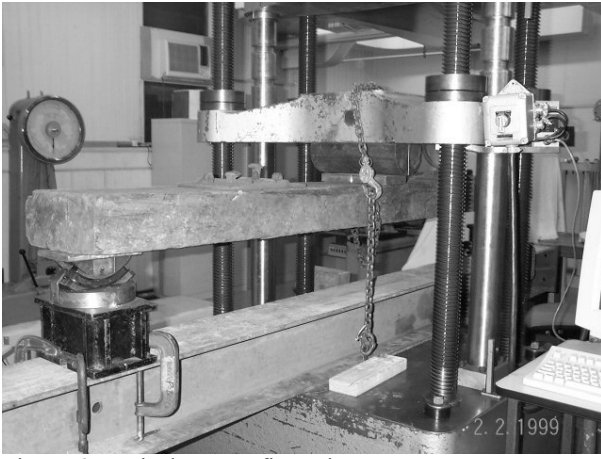
The carbon / timber sleepers were tested to destruction in three-point bending in a universal testing machine. Figure 6 shows the test configuration. The test geometry was given in Figure 3.

Figure 6. Typical test configuration

The specimens were subjected to an increasing monotonic load at a rate of 4mm/minute to destruction. Load, midspan bottom deflection and midspan tensile strain were measured. Figure 7 provides graphical results of the testing and Table 3 provides a summary of results.

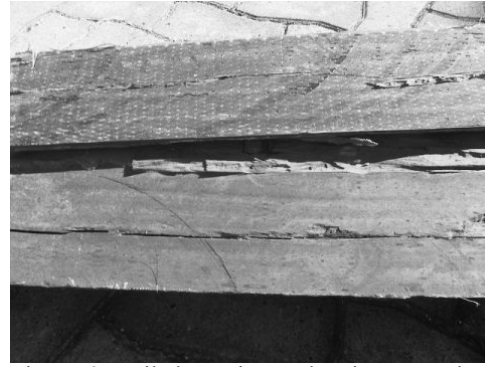
Close visual inspection revealed little penetration into the timber by the epoxy resin. It also appeared that the surface preparation undertaken on the timber resulted in a very smooth surface which had prevented keying of the resin into the wood. Figure 8 shows the failed specimen and the smooth surface on

both the carbon laminate and the timber sleeper indicating poor bonding.

Figure 8. Failed specimen showing smooth surface of timber sleeper (bottom) and smooth surface of carbon laminate (top)

Failure in both cases was instantaneous and catastrophic with no evidence of post failure strength. There was some audible warning of overload just prior to failure. Failure in both cases consisted of delaminating of the carbon / epoxy laminate, with the laminate and the surface of the sleeper remaining in good condition.

Failure of the test specimens occurred due to delamination of the carbon fibre laminates. It is suggested that surface preparation of the timber sleepers may have contributed to this. It is also thought that the low MC and high age of the timber may have also contributed to poor penetration of the resin through tightly packed grain.
